## APPLICATION FOR AVERAGE RATE

To Virginia Insurance Rating Bureau  
Richmond, Virginia

located City of Roanoke, Bedford and Roanoke Counties, Virginia.

RECOMMENDATIONS FOR INSURANCE COVERAGE

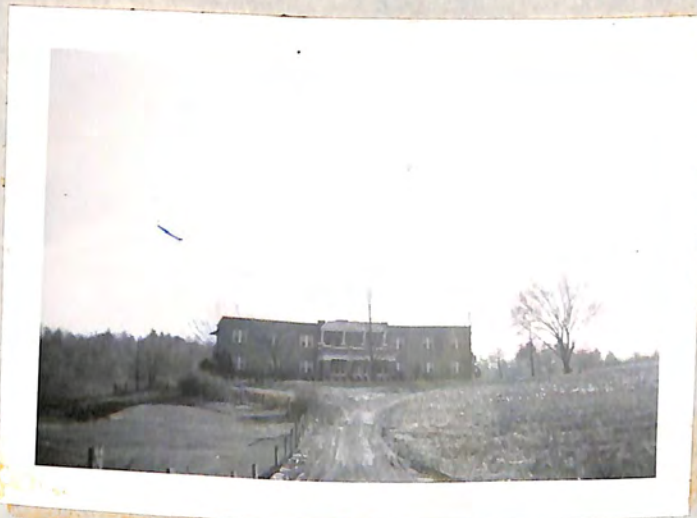
DESCRIPTION: A two story and part basement brick building of fire resistive construction, roof of composition on concrete slab, concrete floors, plastered interior finish, electric lighting, low pressure steam heat. Approximately twenty-five years old and in good condition.

OCCUPANCY: First floor - kitchen, dining room, reception and sleeping rooms. Second floor - sleeping rooms.

VALUATION: The sound value of this building is approximately \$92,000.00.

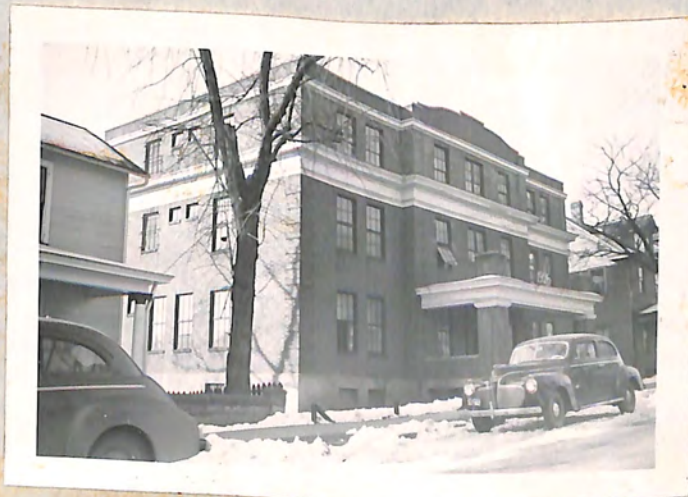
DESCRIPTION: This is a three story and basement and part two story and basement brick building of fire resistive construction with a roof of composition on concrete slab, concrete floors throughout. One open stairs from basement to third floor. Electric lighting and low pressure steam heat. This building is approximately fifteen years old and in good condition.

OCCUPANCY: Offices, matrons' quarters, detention rooms, class room and kitchen.

VALUATION: The sound value of this building is approximately \$105,000.00.

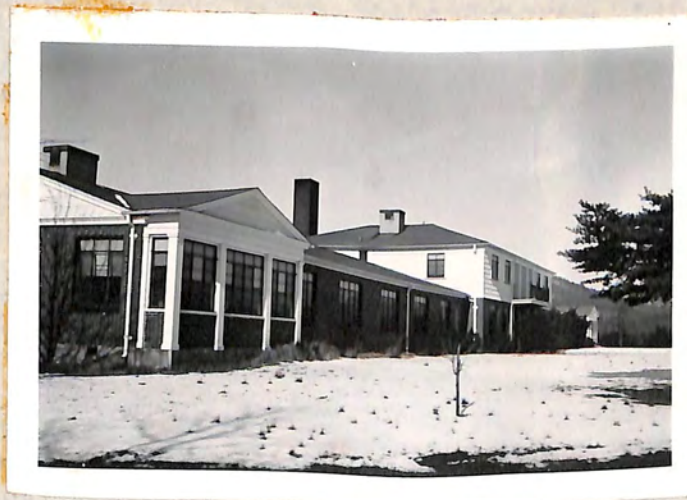
COYNER SPRINGS TUBERCULOSIS SANITORIUM  
Near Bonsack, Virginia

DESCRIPTION: A two and one story part basement building of brick and frame construction with composition shingled roof, concrete floors with tile and wood surfacing, plastered interior finish, electric lighting, low pressure steam heat. Built in 1939 and in excellent condition.

OCCUPANCY: First floor - White and colored ward rooms and private rooms, X-ray offices and examination rooms, kitchen. Second floor - Nurses' quarters. Basement - Heating equipment, storage room.

VALUATION: The sound value of this building is approximately \$180,000.00.

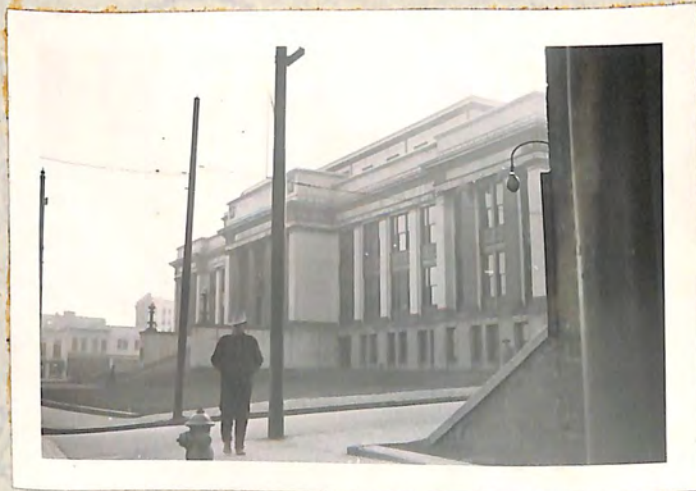
DESCRIPTION: This is a large five story building of fire resistive construction erected in 1916, having a built-up roof, concrete and terrazzo floors, and direct plaster interior finish. There are two open stairs from the first to the third floor, one enclosed stairs from the ground to the fifth floor, one enclosed elevator from the first to the third floor and a small enclosed elevator from the basement to the fifth floor; the lighting is electricity and the heating is low pressure steam. The building is in excellent condition.

OCCUPANCY: Municipal offices and courtrooms, Police Department and City Jail.

VALUATION: The sound value of this building is approximately \$1,050,000.00.

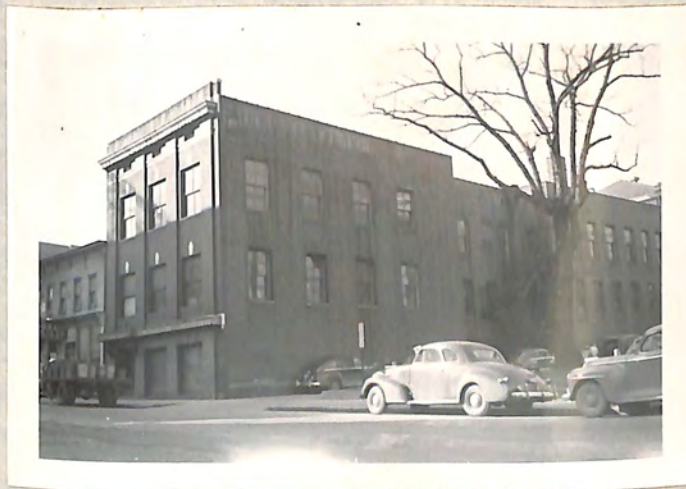
MUNICIPAL BUILDING ANNEX  
319 Second Street, S. W.

DESCRIPTION: This is a two story and basement brick building with metal roof, plank floors with the exception of the basement floor which is concrete, plastered interior finish and one open stairs from basement to second floor, electric lights and low pressure steam heat. The building is in fair condition.

OCCUPANCY: Welfare offices and clinics.

VALUATION: The sound value of this building is approximately \$52,000.00.

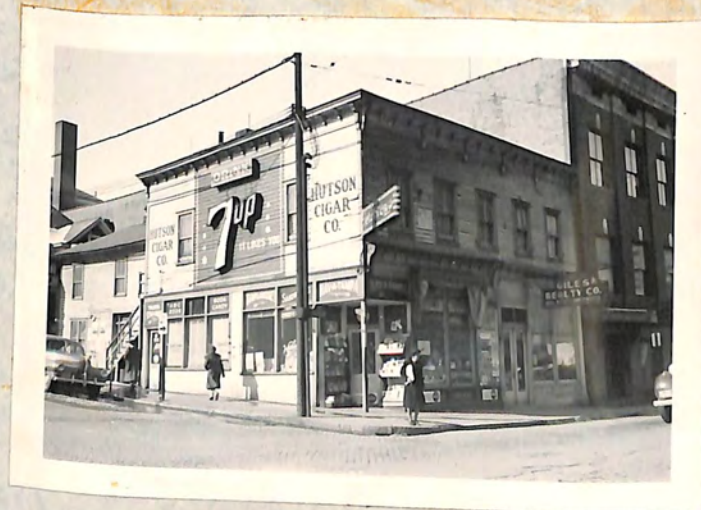
DWELLING AND MERCANTILE BUILDING  
321-323 Second Street, S. W.

DESCRIPTION: This is a two story frame building with metal roof, wood floors, plastered interior finish, electric lights and coal stove heat. This building is approximately fifty years old and in fair condition.

OCCUPANCY: Offices, drugstore and dwelling.

VALUATION: The sound value of this building is approximately \$8,000.00.

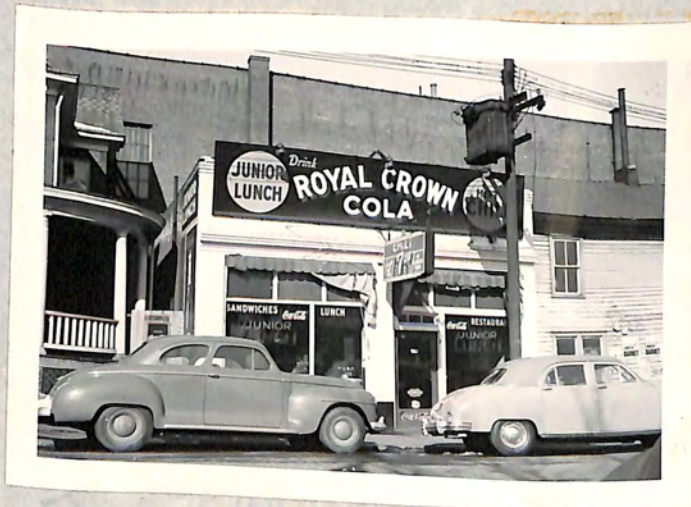
DESCRIPTION: This is a one story brick building with metal roof, wood floors, plastered walls and metal ceiling, electric lights and cooking gas range. This building is approximately thirty years old and in fair condition.

OCCUPANCY: Restaurant.

VALUATION: The sound value of this building is approximately \$4,000.00.

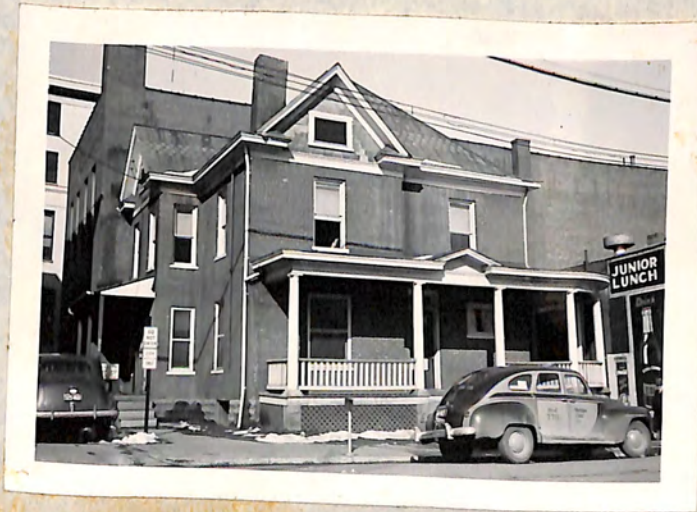
DESCRIPTION: This is a two story and basement brick building with slate roof, wood floors with the exception of the basement which is concrete, plastered walls with the exception of the basement which is open, electric lights and low pressure steam heat. This building is approximately fifty years old and in fair condition.

OCCUPANCY: Offices.

VALUATION: The sound value of this building is approximately \$10,000.00.

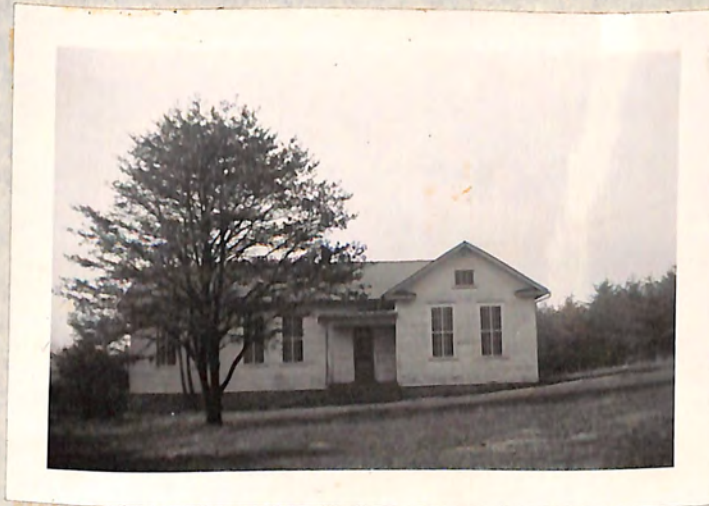
DESCRIPTION: One story part basement frame building, new composition roof, plastered interior finish, wood floors, electric lighting, hot air heat. Building in good condition.

OCCUPANCY: Church of Christ.

VALUATION: The sound value of this building is approximately \$5,000.00.

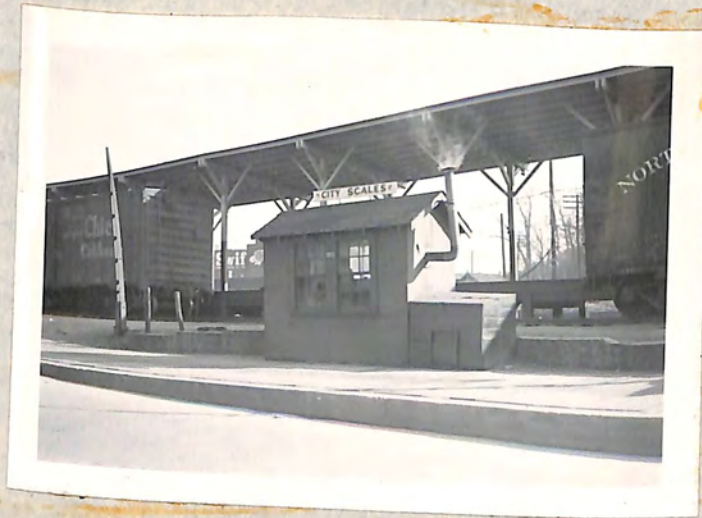
DESCRIPTION: A small one story frame building with composition, shingle roof. Stove heat venting to metal flue; fair repair.

OCCUPANCY: Building houses scale mechanism.

VALUATION: The sound value of this building is approximately \$150.00.

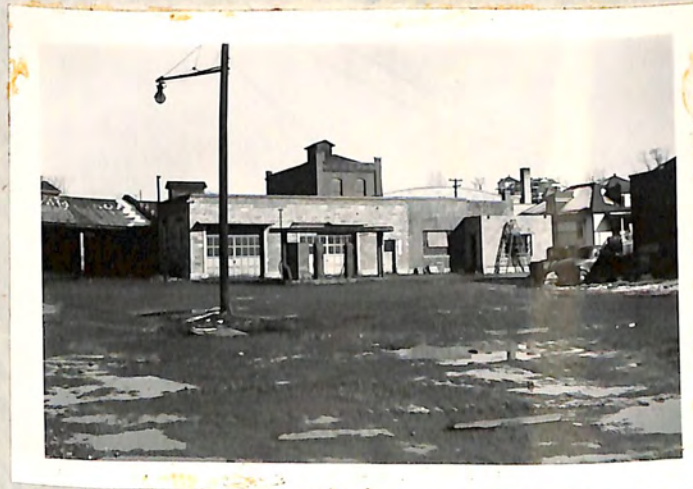
CITY GARAGE - REPAIR SECTION  
Twelfth Street, S. E.

DESCRIPTION: This is a one and two story brick and cinder block building with a roof of composition on wood boards on steel trusses, concrete floor, electric lights and steam heat. Building in fair condition.

OCCUPANCY: Auto and truck repair garage.

VALUATION: The sound value of this building is approximately \$20,000.00.

It is recommended that a concerted effort be made to improve the maintenance and cleanliness of all property. It was noted at the time of this inspection that the housekeeping at the city garage, for example, was sub-standard.

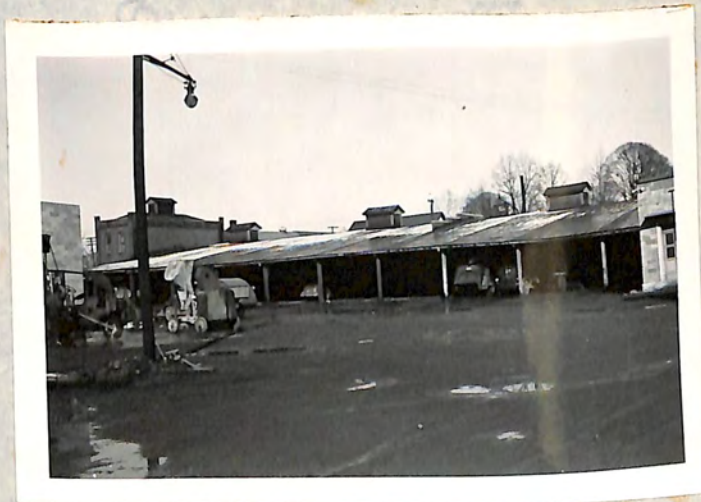
CITY GARAGE - STORAGE SECTION  
Twelfth Street, S. E.

DESCRIPTION: This is a one story and two story brick building with a roof of composition on wood boards on steel trusses, concrete floor, electric lights; no heat. Building is indifferent condition.

OCCUPANCY: Auto and truck storage garage.

VALUATION: The sound value of this building is approximately \$22,000.00.

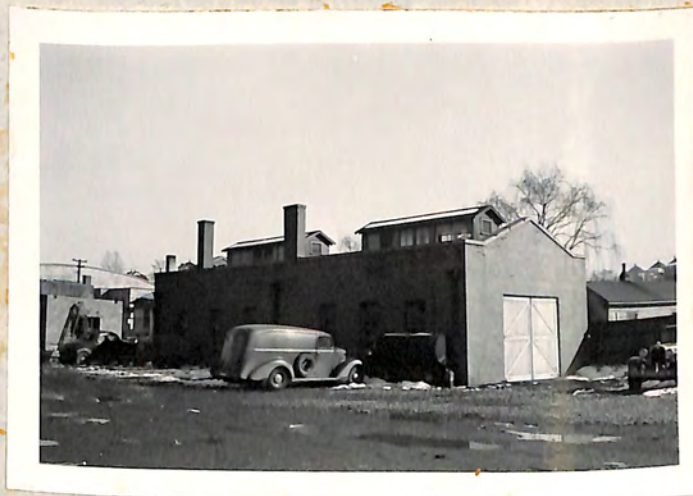
BLACKSMITH SHOP  
At City Garage

DESCRIPTION: This is a one story brick building with a metal roof, earth floor, open interior finish, in fair condition.

OCCUPANCY: Blacksmith Shop.

VALUATION: The sound value of this building is approximately \$5,000.00.

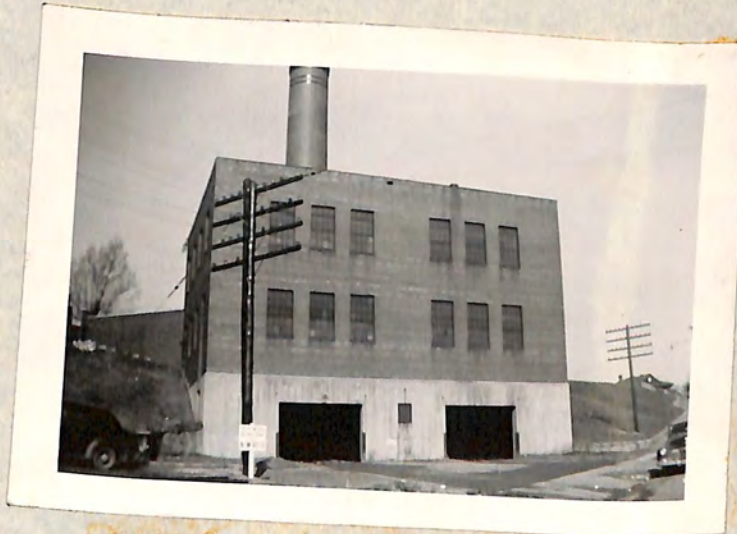
DESCRIPTION: This is a three story building of brick fire resistive construction with roof of composition on concrete slab on unprotected steel, open interior finish, concrete floors, electric lighting. This building is approximately three years old and in excellent condition. There is an 85 foot air-cooled brick stack adjacent thereto.

OCCUPANCY: Furnaces and charging rooms.

VALUATION: The sound value of this building, excluding smoke stack, is approximately \$125,000.00.

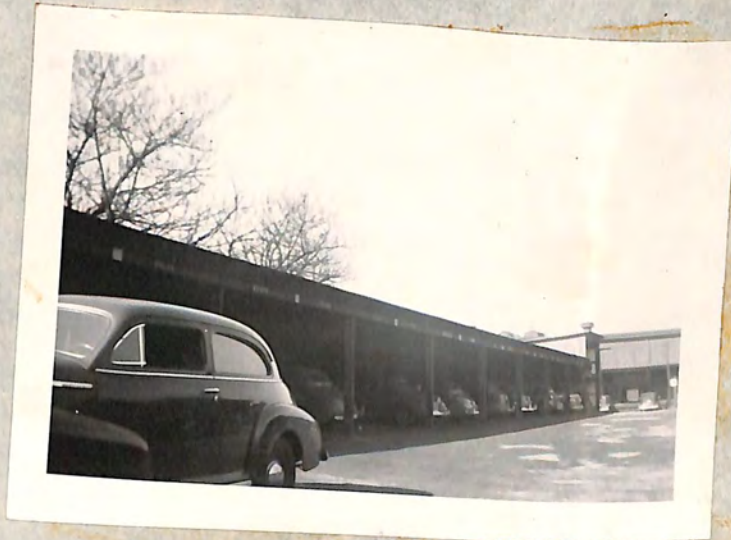
PARKING LOT SHED  
325 Salem Avenue

DESCRIPTION: One and two story frame, metal-clad building with earth floor and metal covered roof.

VALUATION: The sound value of this building is approximately \$6,000.00.

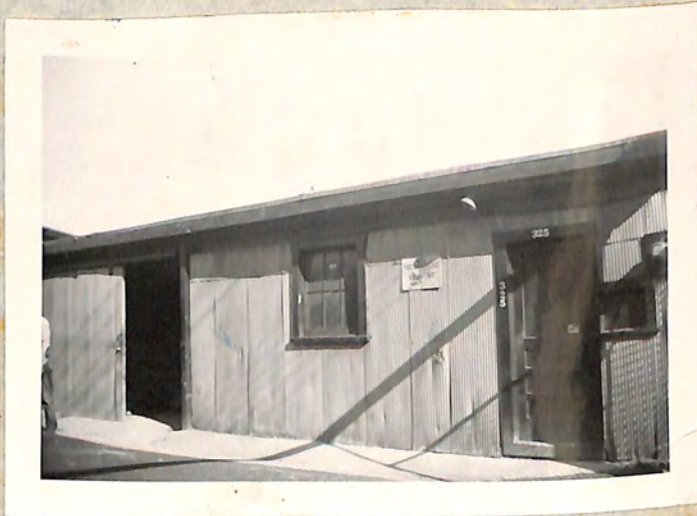
PARKING LOT OFFICE AND TOOL SHOP  
325 Salem Avenue

DESCRIPTION: One story, frame, metal-clad building with earth floor and metal covered roof.

VALUATION: The sound value of this building is approximately \$3,000.00.

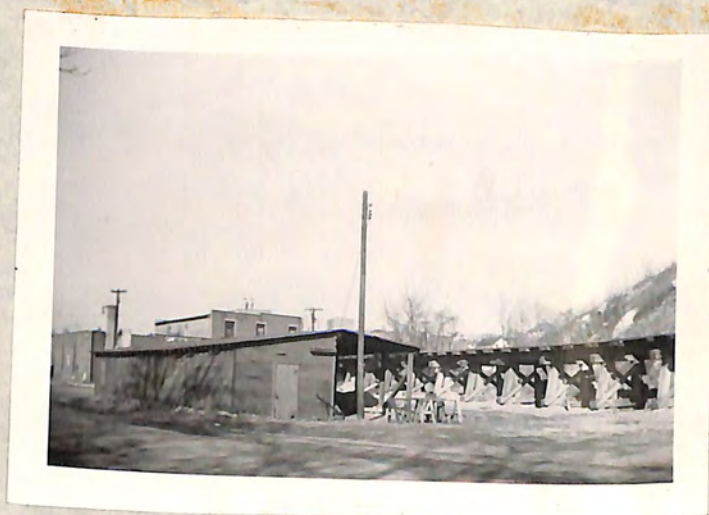
DESCRIPTION: The single track railroad trestle of wood frame construction is approximately 168 feet long elevated at an average height of 9 feet; in poor repair.

VALUATION: The sound value of this trestle is approximately \$1,400.00.

5. Any property which we have recommended to be excluded can be covered under specific policies. For example, bridges and trestles are exposed to many hazards other than fire and lightning and those covered by the Extended Coverage Endorsement, and should be insured under "All risk" policy or policies.

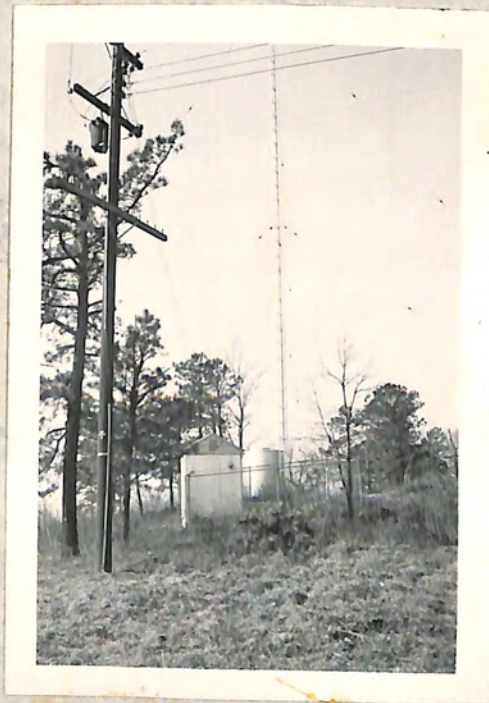
POLICE RADIO BUILDING  
Atop Mill Mountain

DESCRIPTION: This is a one story building having walls of cinder block, metal roof and apparently concrete floor, no heat; in very good condition. Building and fence locked at time of inspection.

OCCUPANCY: Used to house radio transmitter.

VALUATION: The sound value of this building is approximately \$300.00. This figure excludes tower.

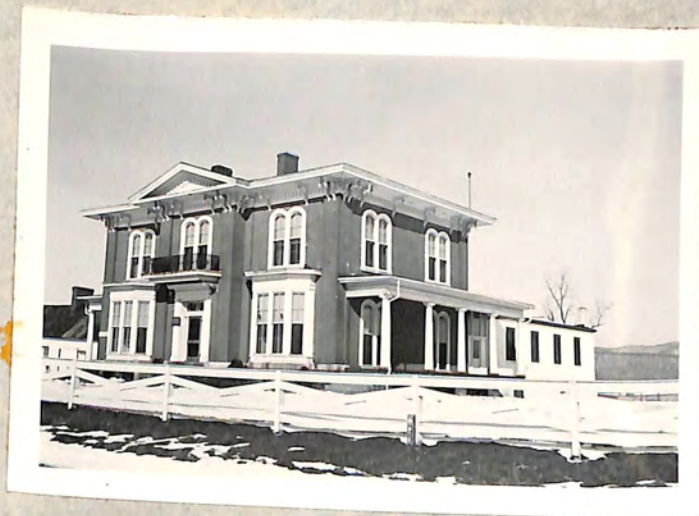
DESCRIPTION: A two story and basement and part one story and basement brick building, metal roof, wood floors except basement which is earth, plastered interior finish, electric lights and steam heat; fair condition.

OCCUPANCY: Office and apartments.

VALUATION: The sound value of this building is approximately \$31,000.00.

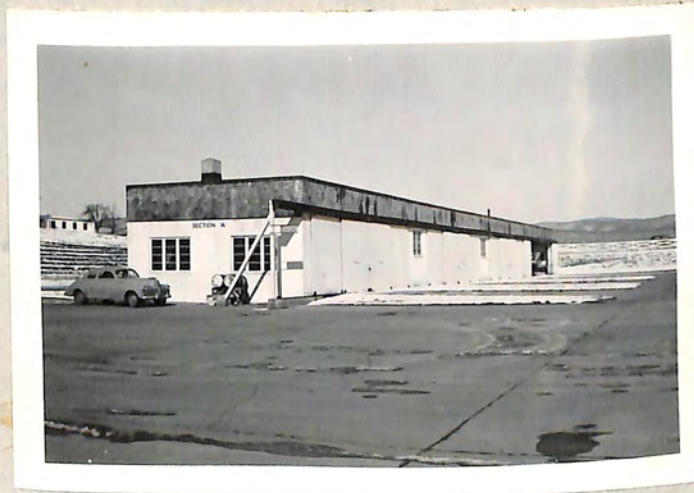
HANGARS A AND B  
At Municipal Airport

DESCRIPTION: Two buildings of similar construction. Each building of cinder block walls with large frame doors, wood joisted roof covered with composition, concrete floor, electric lighting; stove heat. Buildings recently erected and in good repair.

VALUATION: The sound value of Hangar A is approximately \$18,000.00.

The sound value of Hangar B is approximately \$18,000.00.

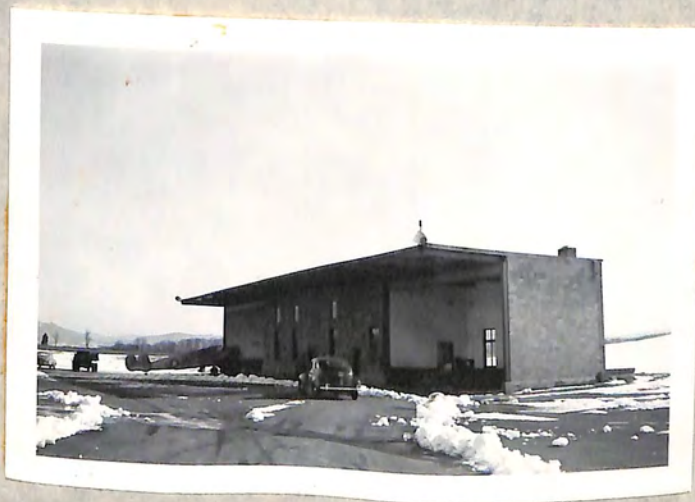
NOSE-IN HANGAR  
Municipal Airport

DESCRIPTION: This is a one-high story building with roof of gypsum plank on unprotected steel, cinder block walls, concrete floor. One side is open. Building of recent construction and in good condition.

OCCUPANCY: Nose-in hangar and office.

VALUATION: The sound value of this building is approximately \$30,000.00.

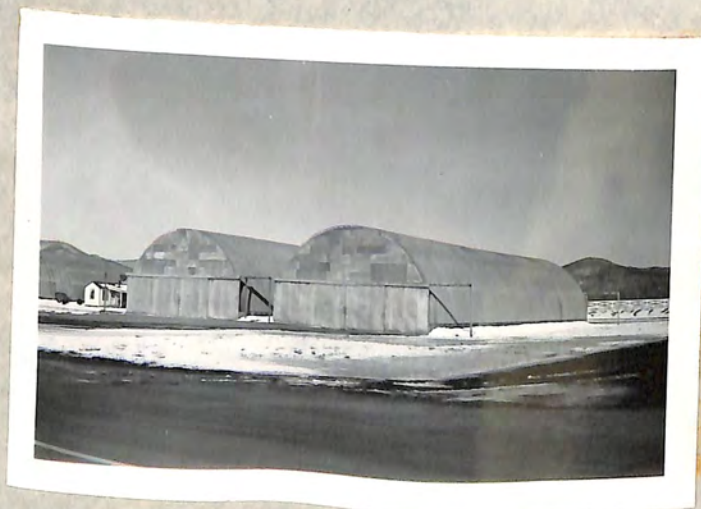
QUONSET HANGARS NOS. 1, 2, 3 and 4  
At Municipal Airport

DESCRIPTION: Four Quonset hut buildings of similar construction. Buildings of all metal on concrete dwarf walls, asphalt floors, electric lighting; no heat. Buildings new and in good condition.

OCCUPANCY: Airplane Storage.

VALUATION: The sound value of Quonset Hangar No. 1 is approximately \$8,000.00.  
The sound value of Quonset Hangar No. 2 is approximately \$8,000.00.  
The sound value of Quonset Hangar No. 3 is approximately \$8,000.00.  
The sound value of Quonset Hangar No. 4 is approximately \$8,000.00.

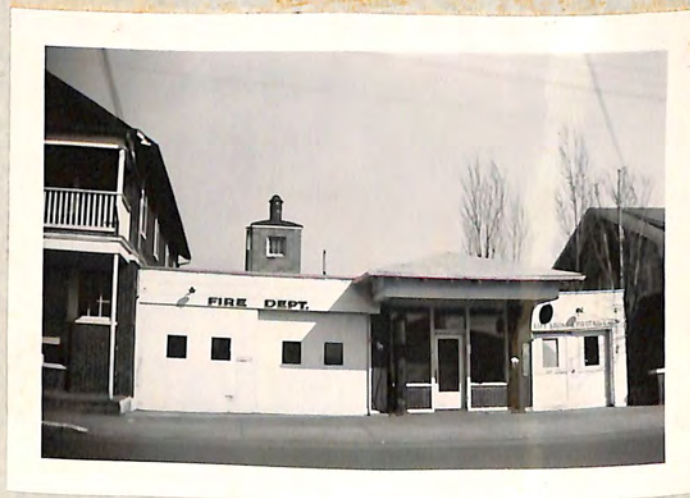
DESCRIPTION: This is a one, two story and part basement of brick-veneer, frame and cinder block, ordinary joisted construction with approved roof. Part of first floor concrete, stove heat; indifferent repair.

VALUATION: The sound value of this building is approximately \$13,000.00.

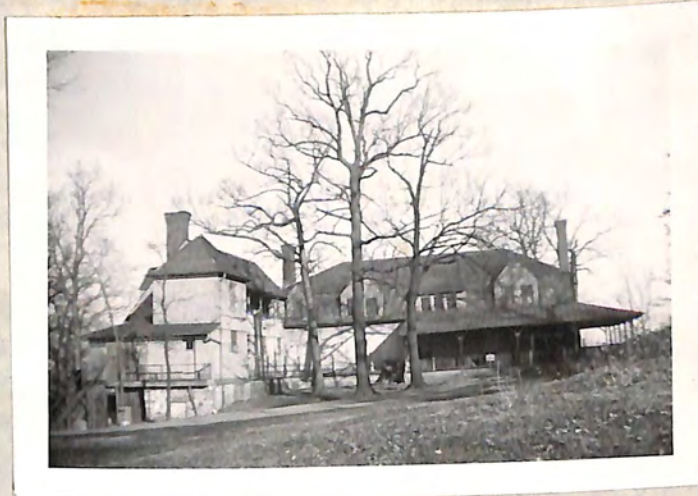
DESCRIPTION: A large two story and basement building, frame clapboard and wood shingle construction, wood shingle roof, board floors, wood board interior finish, electric lighting, heat from stoves and fireplaces; in poor condition.

VALUATION: The salvage value of this building is approximately \$20,000.00.

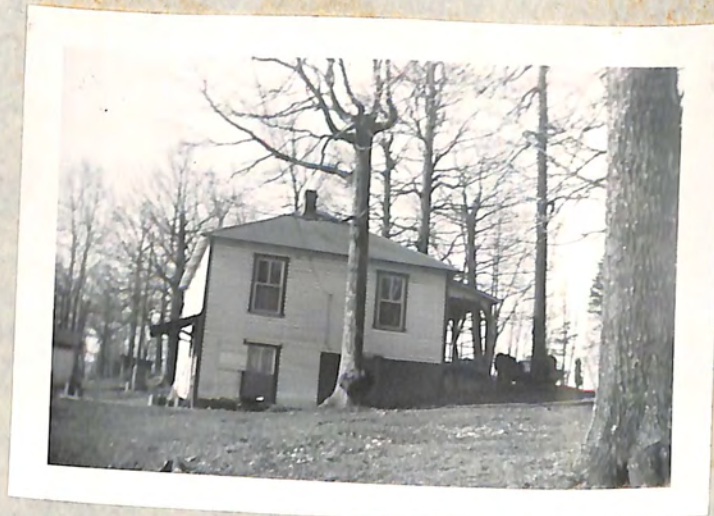
CLUB ROOMS  
Elmwood Park

DESCRIPTION: A one story frame, approved roof dwelling, electric lighting, stove heat; no basement, and in fair repair.

VALUATION: The sound value of this building is approximately \$3,000.00.

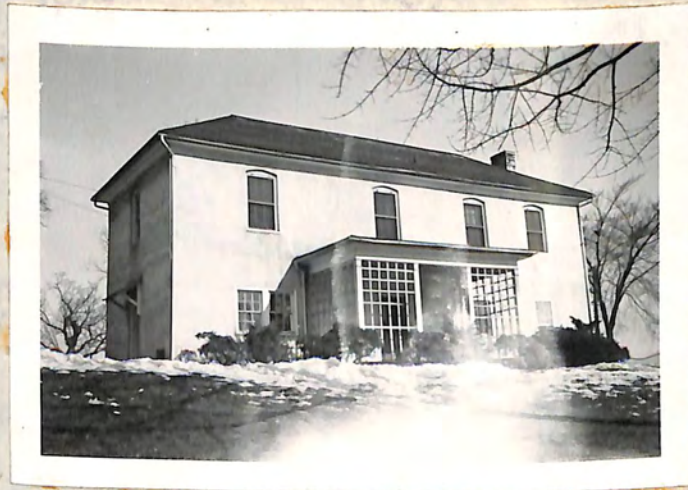
DESCRIPTION: A two story building of brick and stone stuccoed construction with composition shingle roof, wood board floors, plastered interior finish, electric lights, coal-fired Arcola heat. Approximately fifty years old and in good condition.

VALUATION: The sound value of this building is approximately \$5,500.00.

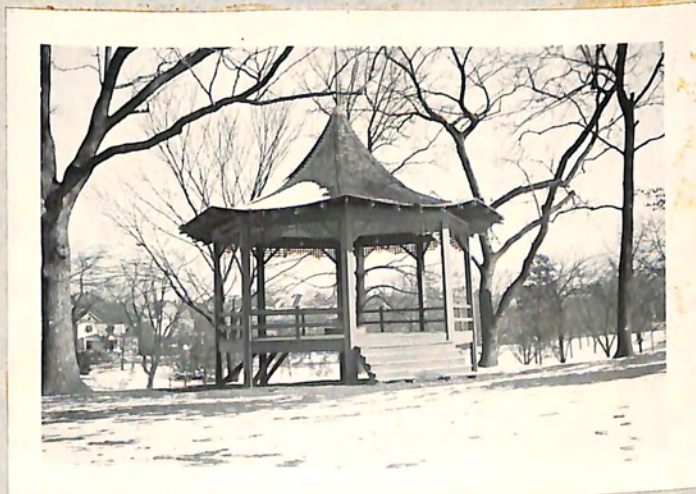
BANDSTAND  
Highland Park

DESCRIPTION: A one story octagonal shaped open pavilion with wood shingle roof, wood floors.

VALUATION: The sound value of this building is approximately \$500.00.

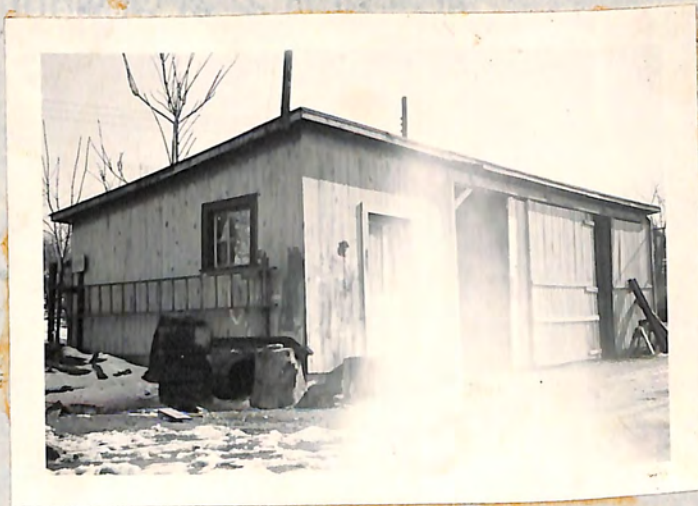
GARAGE  
Highland Park

DESCRIPTION: A one story frame building, composition roof, earth floor, open interior finish.

VALUATION: The sound value of this building is approximately \$1,000.00.

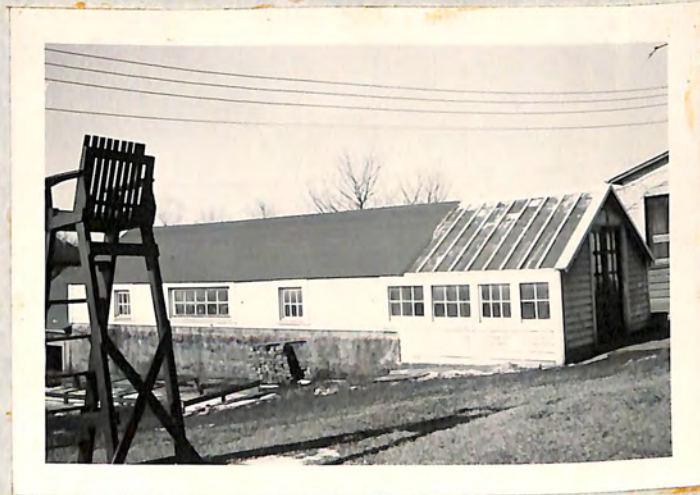
SHOP AND PAINT ROOM (FORMERLY GREENHOUSE)  
Highland Park

DESCRIPTION: A small glass and wood frame greenhouse, concrete floor. There is a small one story frame building attached to each end of the greenhouse, one having composition roof and the other having a metal roof. This building heated with low pressure steam boiler.

VALUATION: The sound value of this building is approximately \$1,600.00.

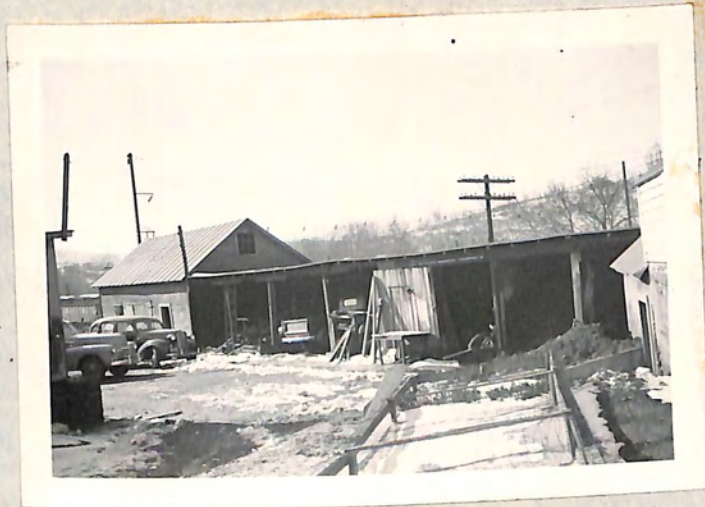
TOOLHOUSE  
Highland Park

DESCRIPTION: A one and a half and one story building of frame construction with metal and composition roof, second floor is wood and remainder earth, open interior finish.

VALUATION: The sound value of this building is approximately \$1,700.00.

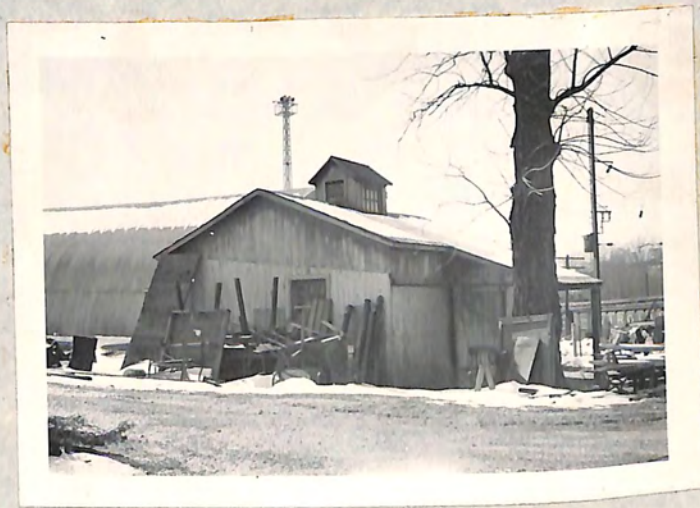
SHOP  
Highland Park

DESCRIPTION: A one story frame building, composition roof, concrete floor, open interior finish, stove heat.

VALUATION: The sound value of this building is approximately \$1,000.00.

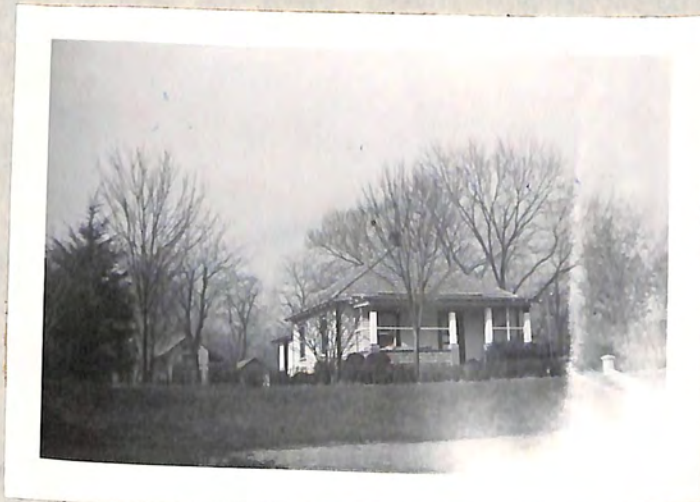
KEEPER'S DWELLING  
Wasena Park

DESCRIPTION: A one story and part basement building of frame construction, concrete shingle roof, wood floors except basement which is concrete, plastered interior finish, electric lighting and coal stove heat. Building approximately twenty-five years old and in good condition.

VALUATION: The sound value of this building is approximately \$3500.00.

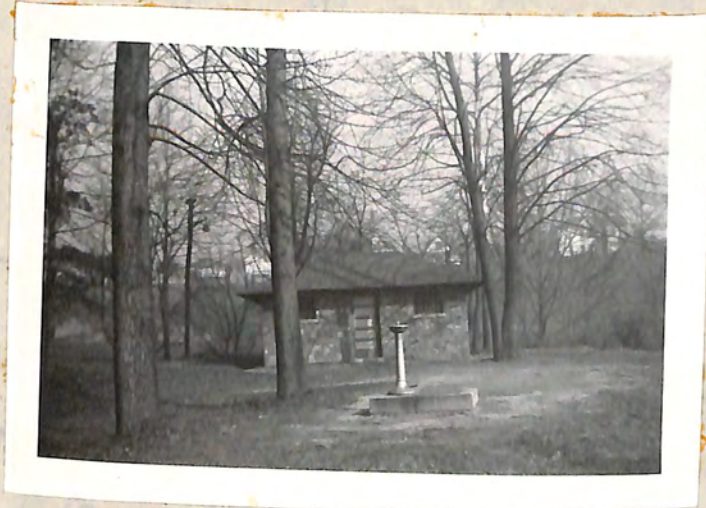
REST HOUSE  
Wasena Park

DESCRIPTION: A one story stone building with composition on wood roof, concrete floor, about ten years old and in good condition.

VALUATION: The sound value of this building is approximately \$2000.00.

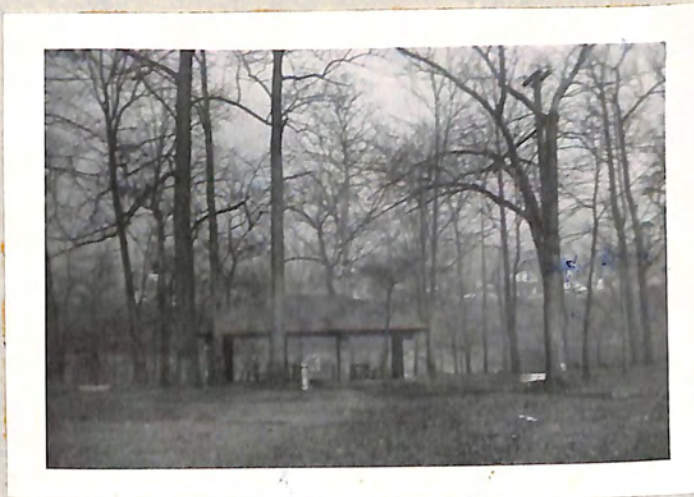
PAVILION  
Wasena Park

DESCRIPTION: A one story open pavilion with stone pier roof supports, composition shingle on wood roof, concrete floor.

VALUATION: The sound value of this building is approximately \$1300.00.

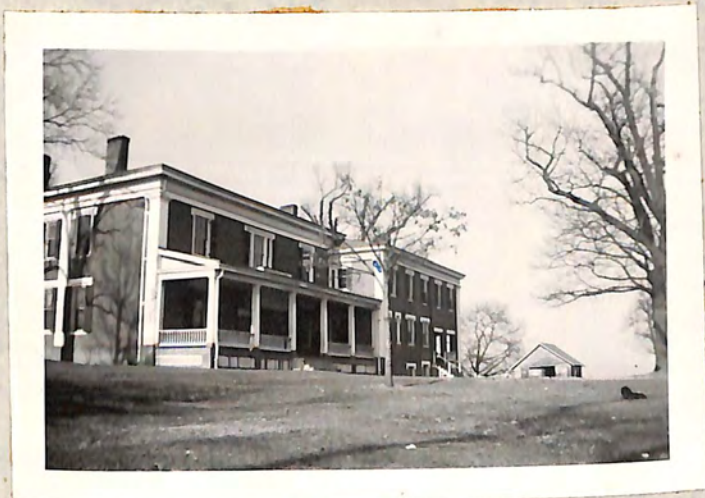
RECREATIONAL BUILDING AND KEEPER'S DWELLING (BUENA VISTA)  
Jackson Park

DESCRIPTION: A two story and part basement brick building with metal roof, wood floors, plastered interior finish, three stairs first to second floor, one stairs basement to first floor. Electric lighting and low pressure steam heat. About one hundred years old and in fair condition.

VALUATION: The sound value of this building is approximately \$42000.00.

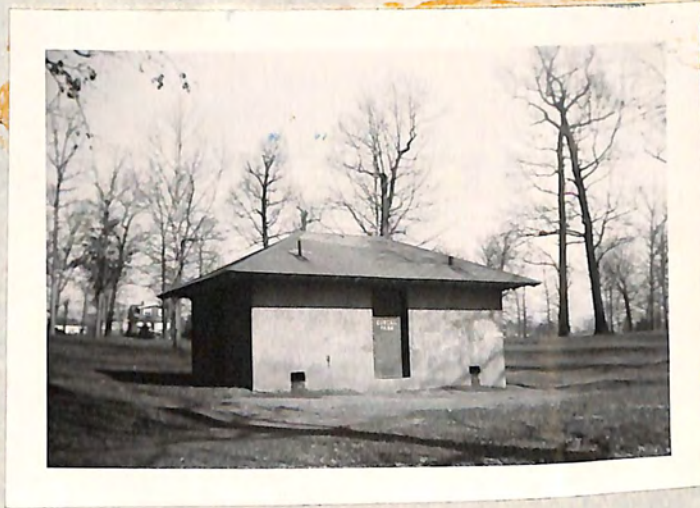
REST HOUSE  
Eureka Park

DESCRIPTION: A one story concrete building with composition roof and concrete floors.

VALUATION: The sound value of this building is approximately \$1,000.00.

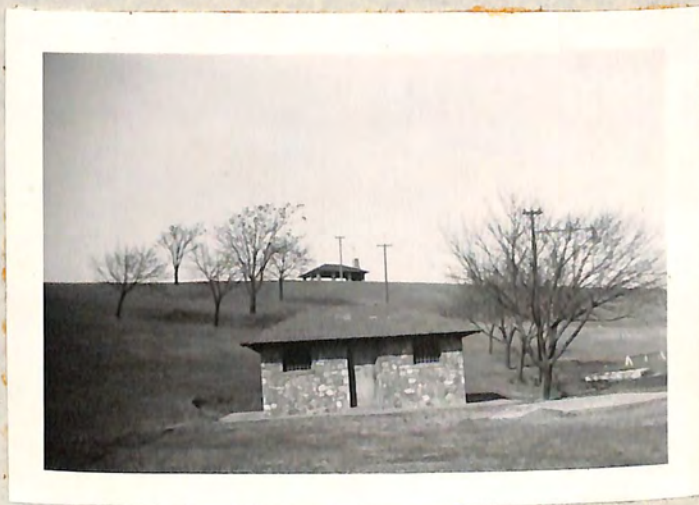
REST HOUSE  
Fallon Park

DESCRIPTION: A one story stone building with composition roof and concrete floors.

VALUATION: The sound value of this building is approximately \$2000.00.

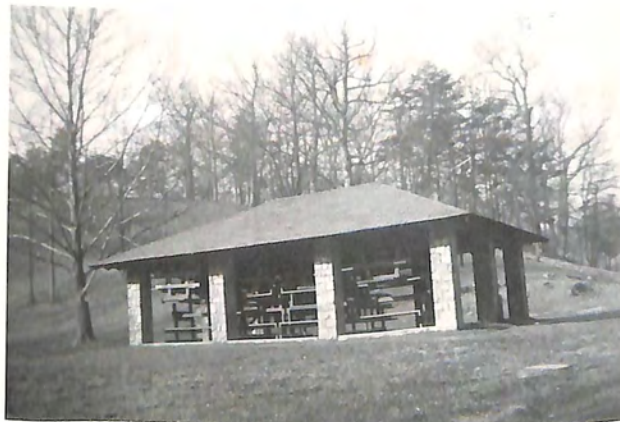
PAVILION  
Fishburn Park

DESCRIPTION: A one story open pavilion with stone pier roof supports, composition roof and stone floor.

VALUATION: The sound value of this building is approximately \$1300.00.

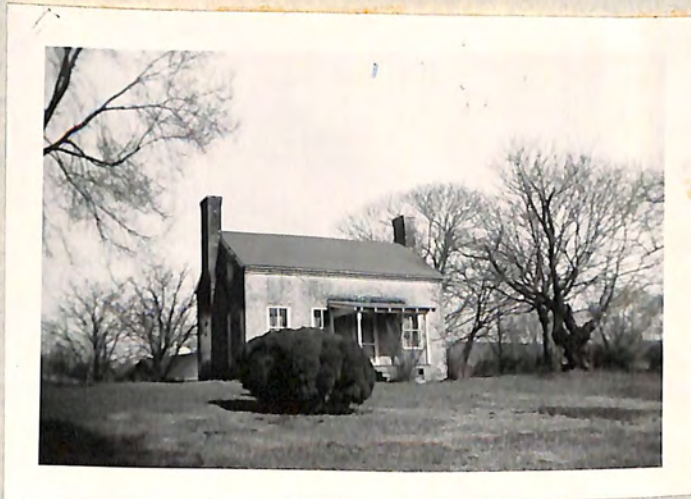
KEEPER'S DWELLING  
Washington Park

DESCRIPTION: A two story brick building with frame addition and approved roof, wood floors, plastered interior finish, stove heat and electric lighting. Building in fair condition.

VALUATION: The sound value of this building is approximately \$3,500.00.

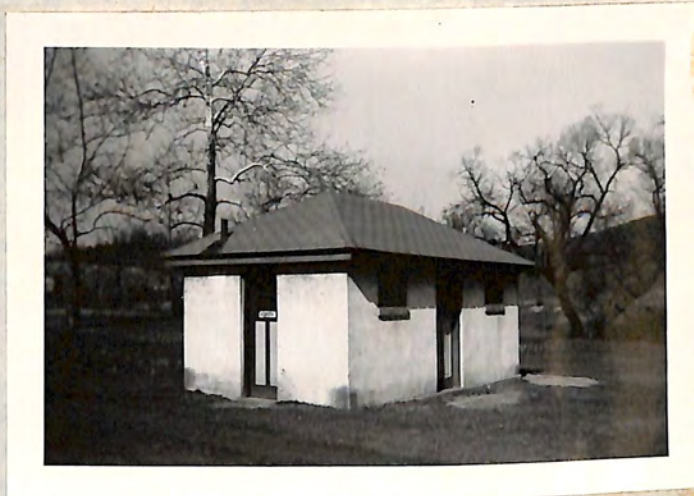
REST HOUSE  
Washington Park

DESCRIPTION: A one story stuccoed tile constructed building with composition roof and concrete floor.

VALUATION: The sound value of this building is approximately \$1,500.00.

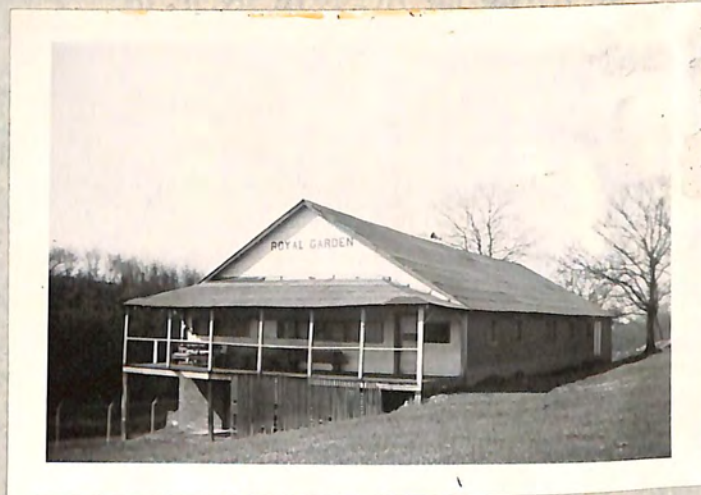
SHELTER HOUSE  
Washington Park

DESCRIPTION: A one story and basement frame, approved roof building, with wood floor.

VALUATION: The sound value of this building is approximately \$4,000.00.

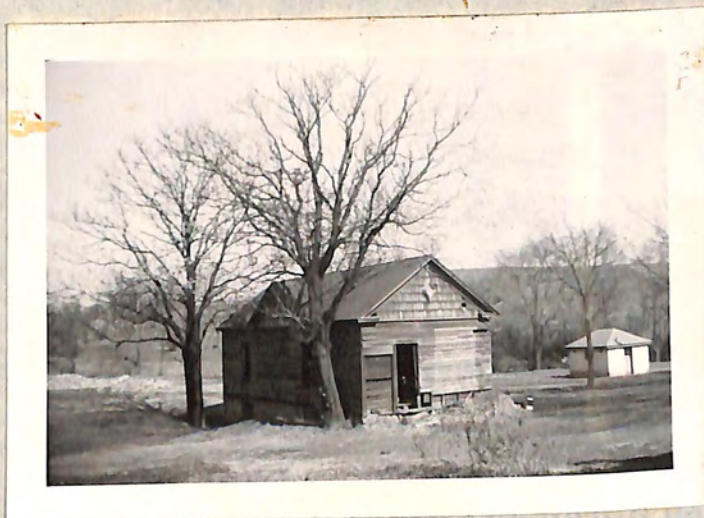
STORAGE BUILDING  
Washington Park

DESCRIPTION: A one story frame, approved roof building.

VALUATION: The sound value of this building is approximately \$250.00.

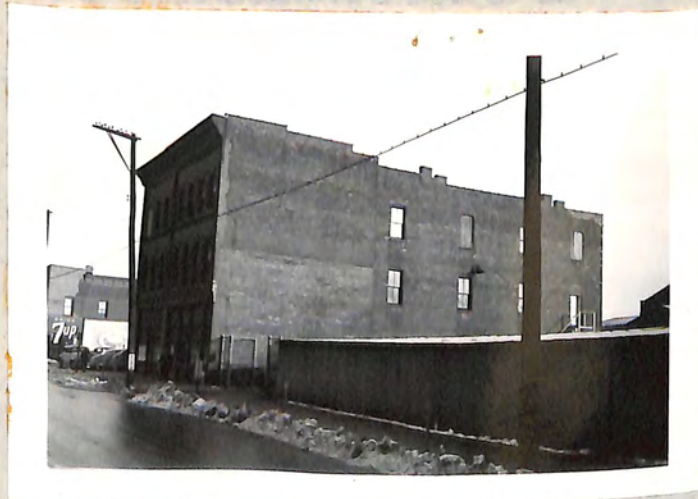
METER SHOP  
23-25 East Norfolk Avenue

DESCRIPTION: A three story brick building with a metal roof, wood floors with the exception of first floor which is concrete, wood lath and plaster interior finish, electric lighting, stove heat. Approximately fifty years old and in poor condition. This building is an old apartment building, the first floor of which has been converted into a meter shop.

VALUATION: The sound value of this building is approximately \$34,000.00.

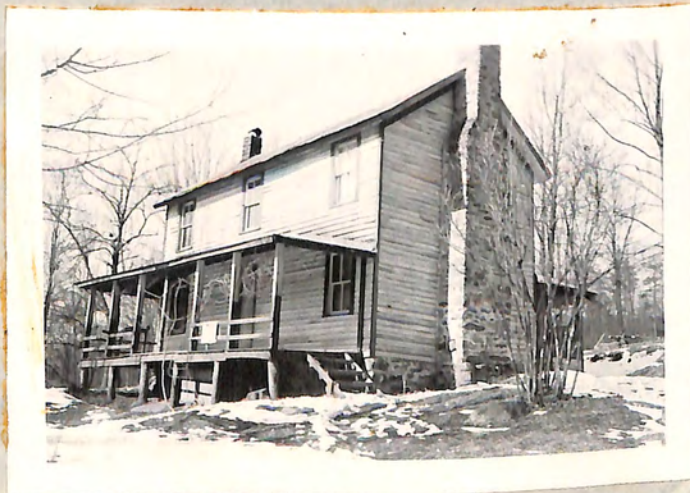
TENANT DWELLING  
Old Spratlin Place, near Beaver Dam

DESCRIPTION: A one and a half and one story building of frame construction, composition roof, wood floors, plastered interior finish, electric lighting, stove heat. Building approximately forty years old and in fair condition. Small frame outbuilding on premises.
